In mid 2006, a painter was killed when he fell 20' from the roof of a townhouse. The work involved exterior re-painting of the units. The process involved sanding the walls,

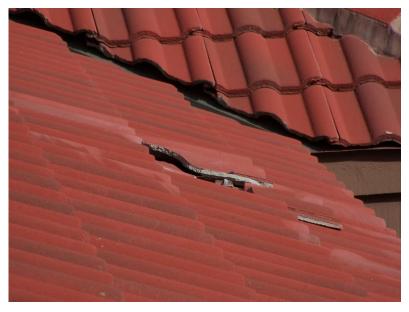
After sanding some walls, the victim had climbed outside onto the roof pulling a water hose with him. He would shoot the water onto several walls while standing on the Monier tiled roof. On that day, his attire was shorts, t-shirt and rubber slippers. A co-worker had observed the water being sprayed onto the walls, heard a sound, and found the victim on the ground.

An inspection of the roof found that several damaged tiles at the point the victim had fallen. It is believed that the victim's walking on the tiles had damaged the tiles causing him to slip and fall over the edge to his death. The employee was not tied off and the employer provided no training in fall protection.

- 1. Inspect all walking/working surfaces before use to determine if it has sufficient strength and structural integrity to support the employees safely. If necessary to walk on tile roofs, use recommended walking boards, or other secured, weight-distributing surfaces.
- 2. Provide fall protection, i.e. guard rails, safety nets or personal fall arrest systems, when working at heights greater than 6 feet to the lower level.
- 3. Provide fall protection training to employees who may work at heights greater than 6 feet.
- 4. Provide body harnesses as part of a personal fall arrest system. Body belts were disallowed effective January 1, 1998.
